CONCRETE FLOORS – LAITANCE

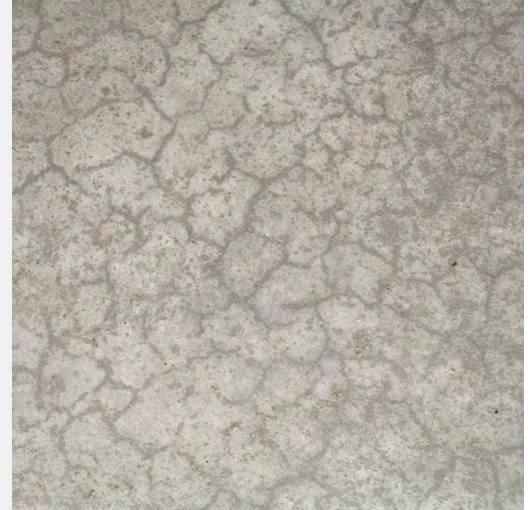
Laitance and shrinkage cracks

Laitance can be removed using diamond grinding, shot blasting or other mechanical methods, and the resultant sound concrete surface can be painted with confidence.

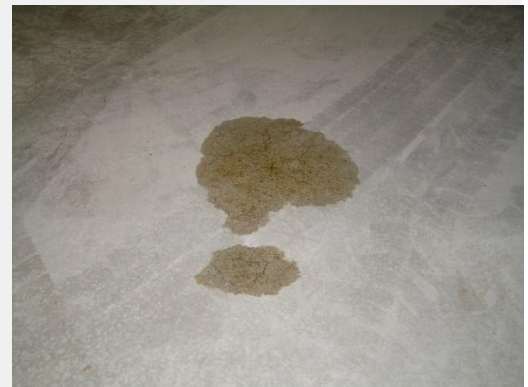
Oil stains and tyre marks on laitance-covered floor
